**Re: Major Municipal; SIC 4952; Compliance Evaluation Inspection; City of Tucumcari
Wastewater Treatment Plant; NPDES Permit No. NM0020711; November 14, 2016**

City of Tucumcari Wastewater Treatment Plant

Compliance Evaluation Inspection
NPDES Permit Number NM0020711

November 14, 2016

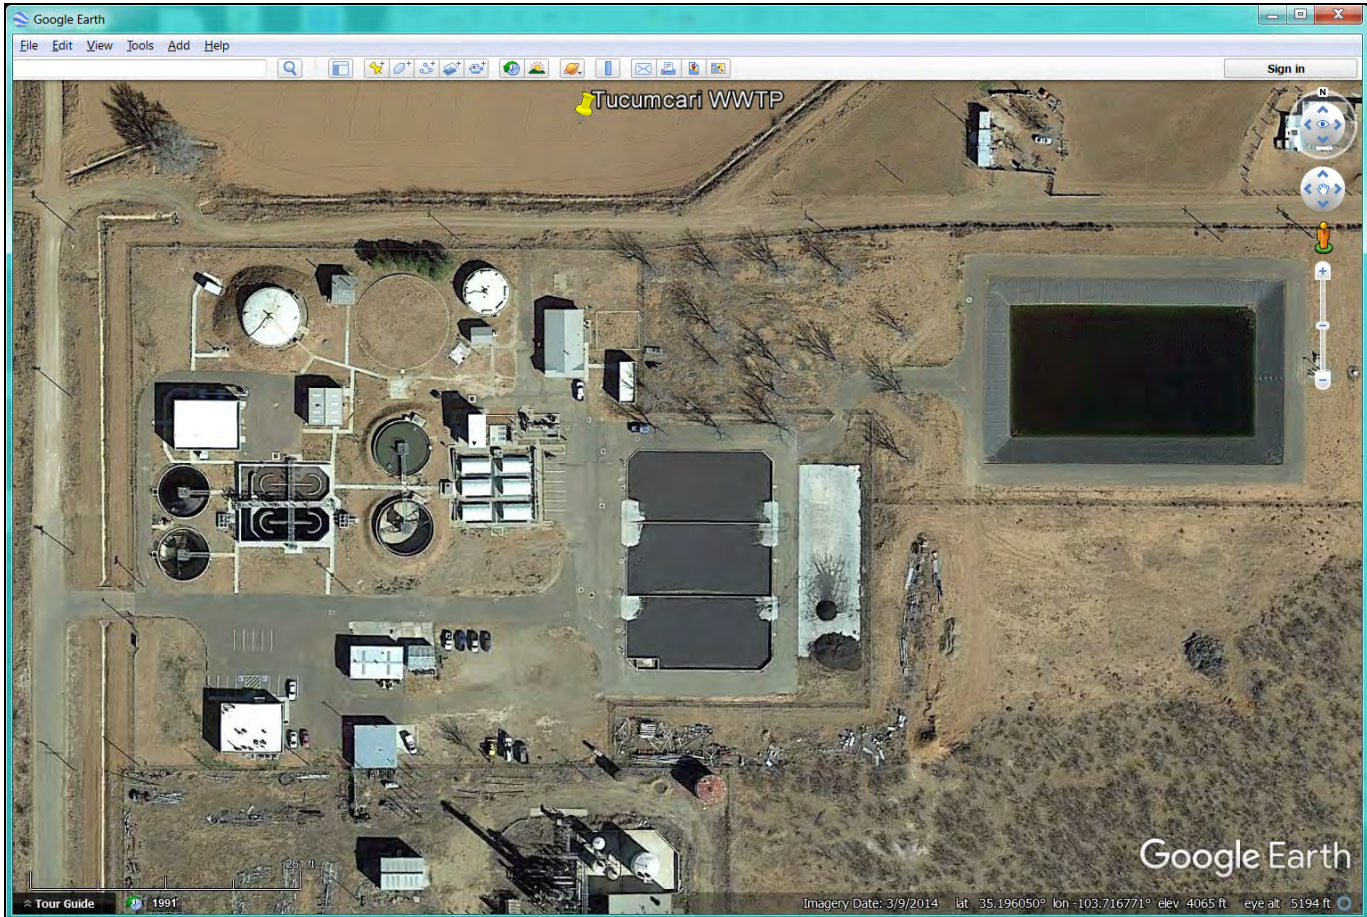
Location: City of Tucumcari Wastewater Treatment Plant

Subject: Google Earth Aerial View of the Wastewater Treatment Plant

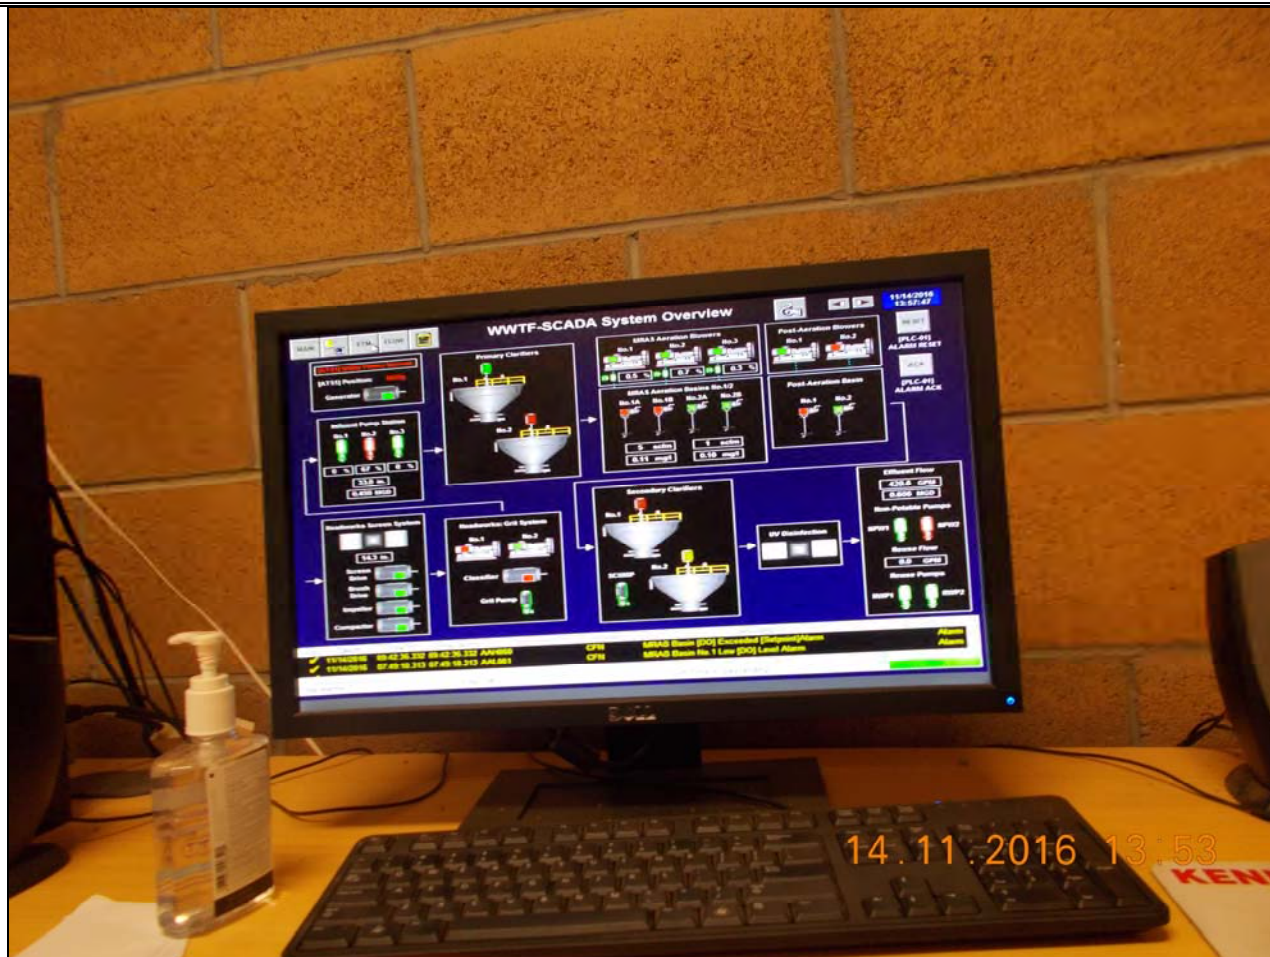
<p align="center">WMED/SWQB Official Photograph Log Photo # 2</p>		
Photographer: Barbara Cooney	Date: November 14, 2016	Time: 13:53 Hours
City/County: Tucumcari / Quay		State: New Mexico
Location: City of Tucumcari Wastewater Treatment Plant		
Subject: SCADA plant operating system shows the status of each treatment unit.

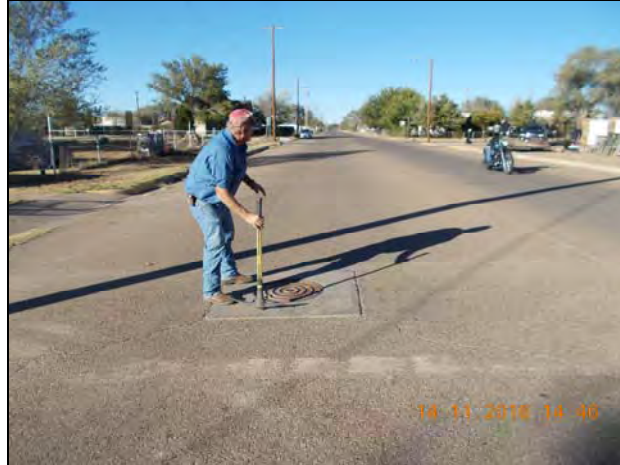
**NMED/SWQB
Official Photograph Log
Photo # 3**

Subject: Manhole where the waste from the cheese factory meets the domestic waste in the collection system.

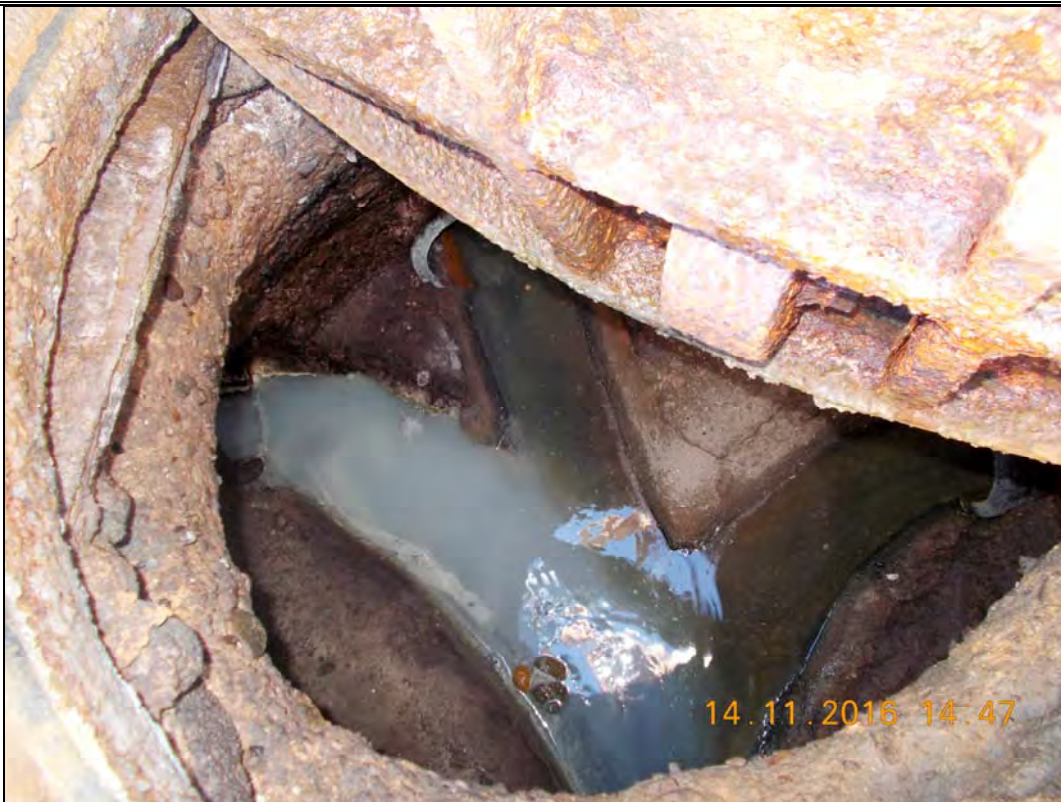
**NMED/SWQB
Official Photograph Log
Photo # 4**

It was observed that floating white substances were present in the primary and secondary clarifiers. This white substance is suspected to be from the Cheese Factory waste.

Subject: Manhole at the sewer line where the waste from the cheese factory meet domestic waste. The white is from the cheese factory. The cheese factory has a holding tank that they have chosen to not use and the city had no control of the flow from that facility at the time of the inspection.

Since the last inspection the permittee has developed a pre-treatment program and sewer ordinances, with local limits, monitoring requirements and enforcement penalties to be applied for non-compliance from the contributing industry (see attached ordinances). However, monitoring records provided by the permittee showed data on a periodic basis rather than consistent monitoring. The cheese factory has installed a holding tank however the city has no control over the release of the waste into the collection system. The permittee is not following their own sewer ordinances to protect the WWTP operations.

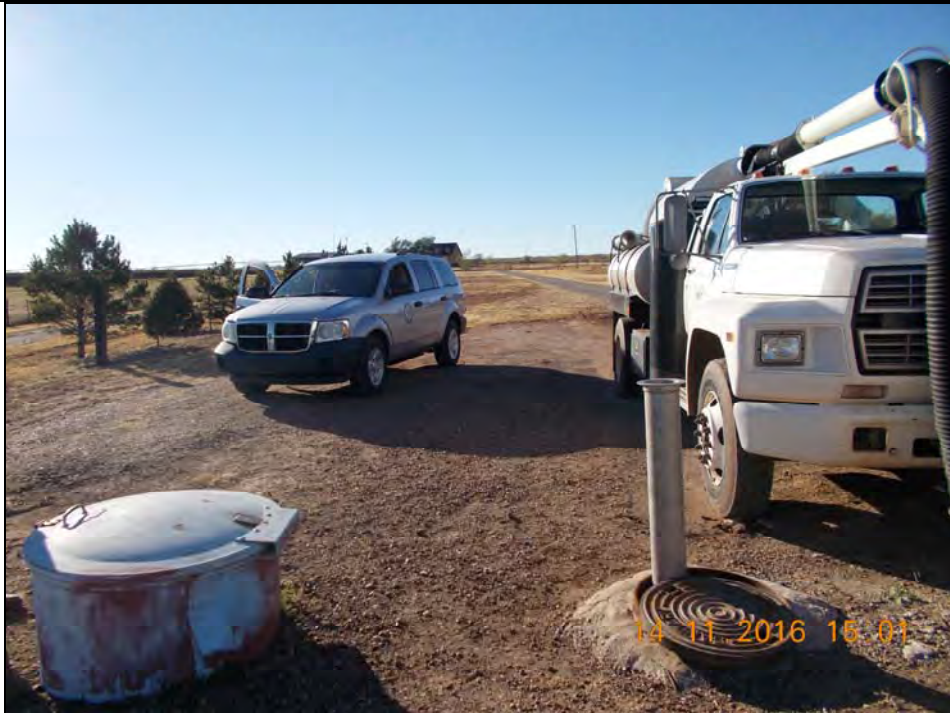
**NMED/SWQB
Official Photograph Log
Photo # 5**

2. A portion of the collection system under the Interstate 40 is collapsed and has been for more than a year. Operators use a vactor truck daily to remove accumulated waste from a wet well on the far side of the collapsed line at the KOA campground. It is advisable for the permittee to contact the Department of Transportation or Federal Highway Administration to correct and/or replace the collapsed line. There was no evidence at the wet well of spillage and overflow.

Subject: KOA campground the old clay pipe has collapses from this location and under Interstate 25 where the line is located as it connects to the rest of the City's system. Until a new collection line is constructed, the town must vector out of this wet well daily then drain the vector truck to another manhole closer to the WWTP. Collapsed clay lines and older cast iron lines are a common problem in old collection systems that have not been upgraded. According to operators the bedding for the sewer line was not properly laid when the Highway was built causing the compression that collapsed the line.

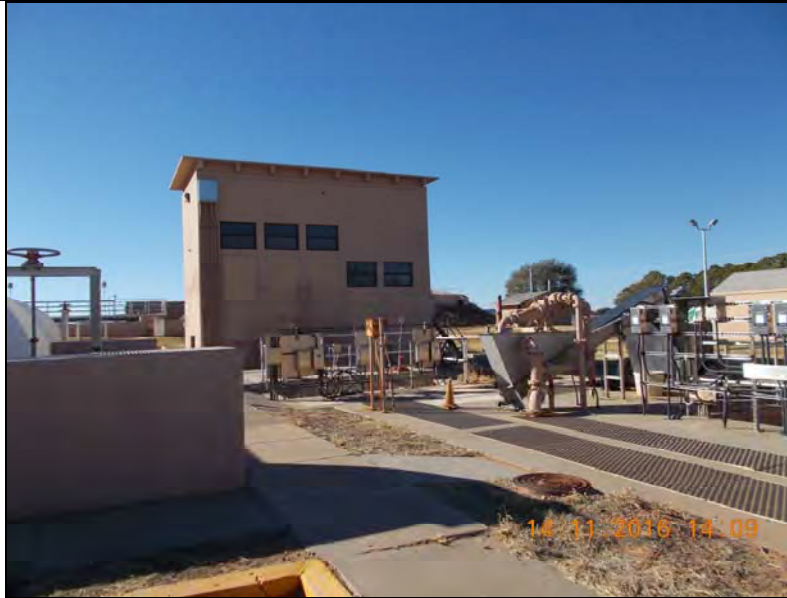
**NMED/SWQB
Official Photograph Log
Photo # 7**

Subject: Headworks consist of parallel channels, one manual and one with a mechanical grinder and screen. Grit removal is collected, ground, compressed and dumped into a hopper taken to the landfill. Following grit remover are 3 Flygt pumps that are on floats.

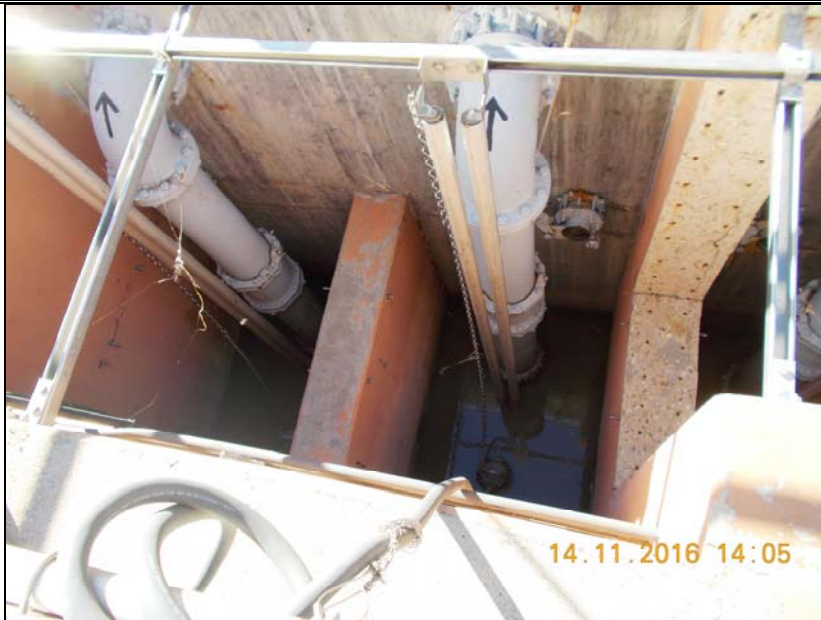
**NMED/SWQB
Official Photograph Log
Photo # 8**

Subject: Headworks consist of parallel channels, one manual and one with a mechanical grinder and screen. Grit removal is collected, ground, compressed and dumped into a hopper taken to the landfill. Following grit remover are 3 Flygt pumps that are on floats. The pumps use is on rotation to prevent uneven wear.

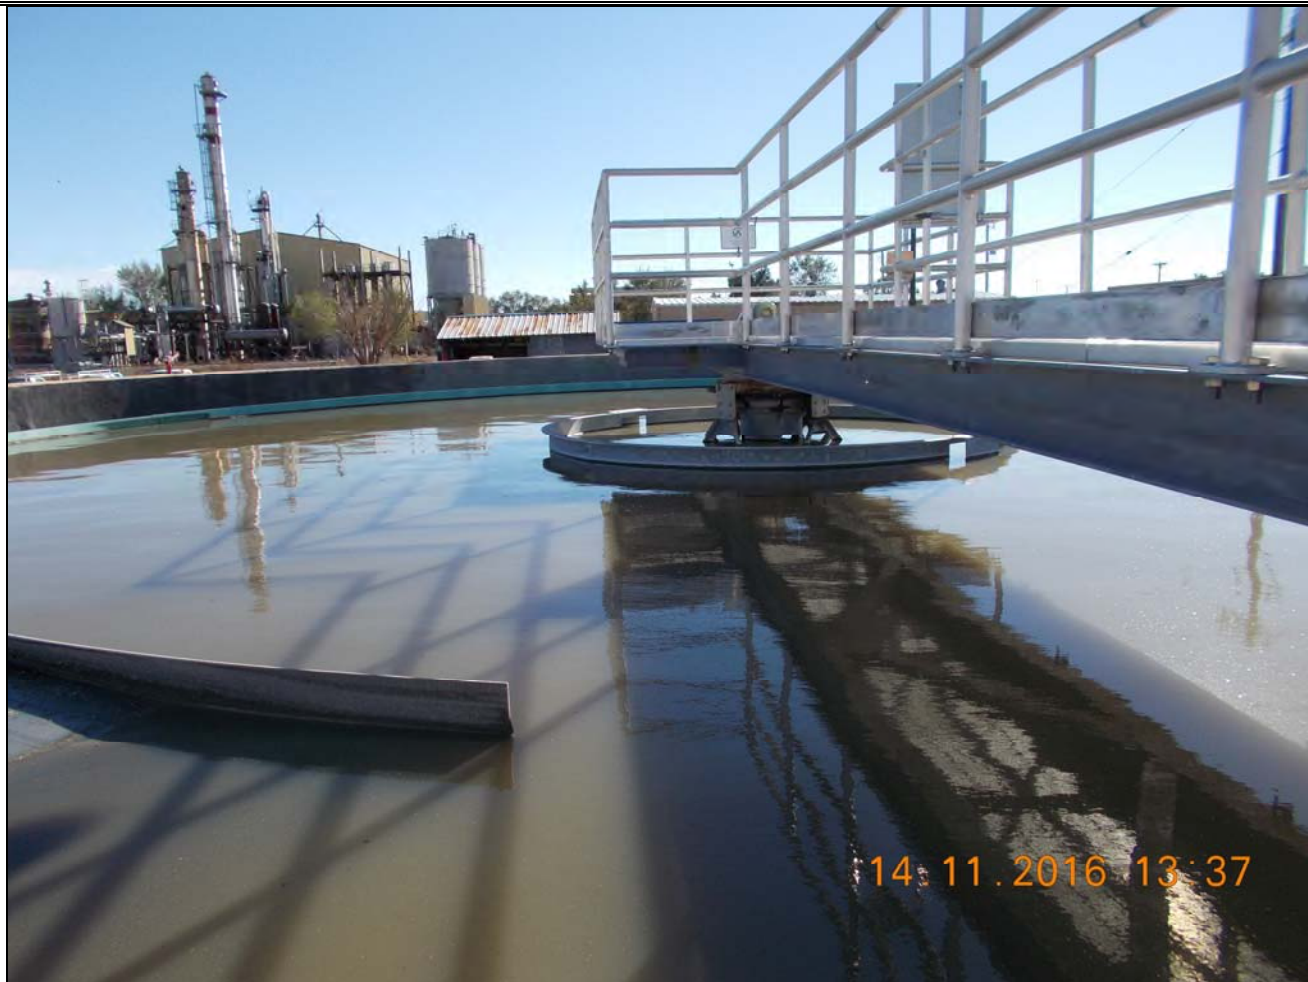
**NMED/SWQB
Official Photograph Log
Photo # 9**

1. Floating white material was observed on the surface of both the primary and secondary clarifiers. The floating solids were more apparent on the secondary clarifier after biological treatment and other process had removed the majority of the solids.

Subject: Primary clarifiers follow the headworks. Though not obvious in this photo there were some floating white particles in what appeared to be dairy or cheese waste.

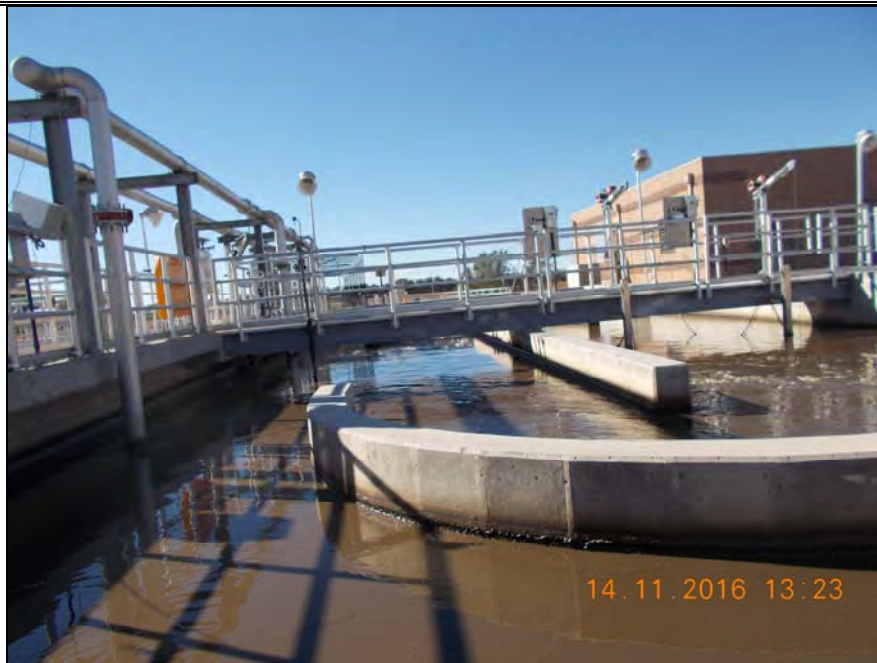
**NMED/SWQB
Official Photograph Log
Photo # 10**

Subject: The oxidation ditch for extended aeration has a detention time (DT) of approximately 20 days for the sewage water. Dosing with polyaluminium chloride (PAX-14 ©) to reduce bulking and foaming problems that are aggravated by the high volumes of waste from the cheese factory. There was very little foam present and staining on the walls of the basin did not show a high volume of foam at other times. The addition of PAX-14 also allows for better solids separation. The aeration on and off cycles vary depending on season. In winter the air is on for 1.5 hours and off for 1 hour. The Dissolved Oxygen sensor are mounted on the crosswalk in the photo below and during the aeration phase DO is 4 -6 mg/L and in the anoxic phase DO is 0.06 mg/L. The basin at the time of this photo was in an anoxic phase with the bottom mixers on.

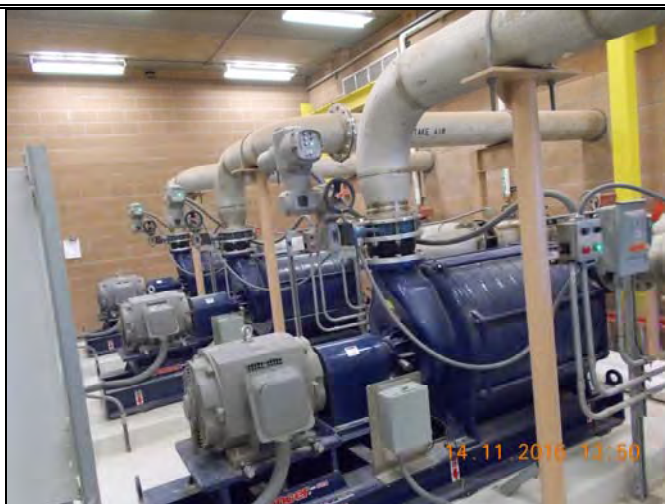
**NMED/SWQB
Official Photograph Log
Photo # 11**

Subject: The blowers for the aeration basins are fixed rate and not variable speed. Operators indicated the blower are oversized for a single basin. The blowers are run one at a time and use is rotated between them to minimize wear on any one blower.

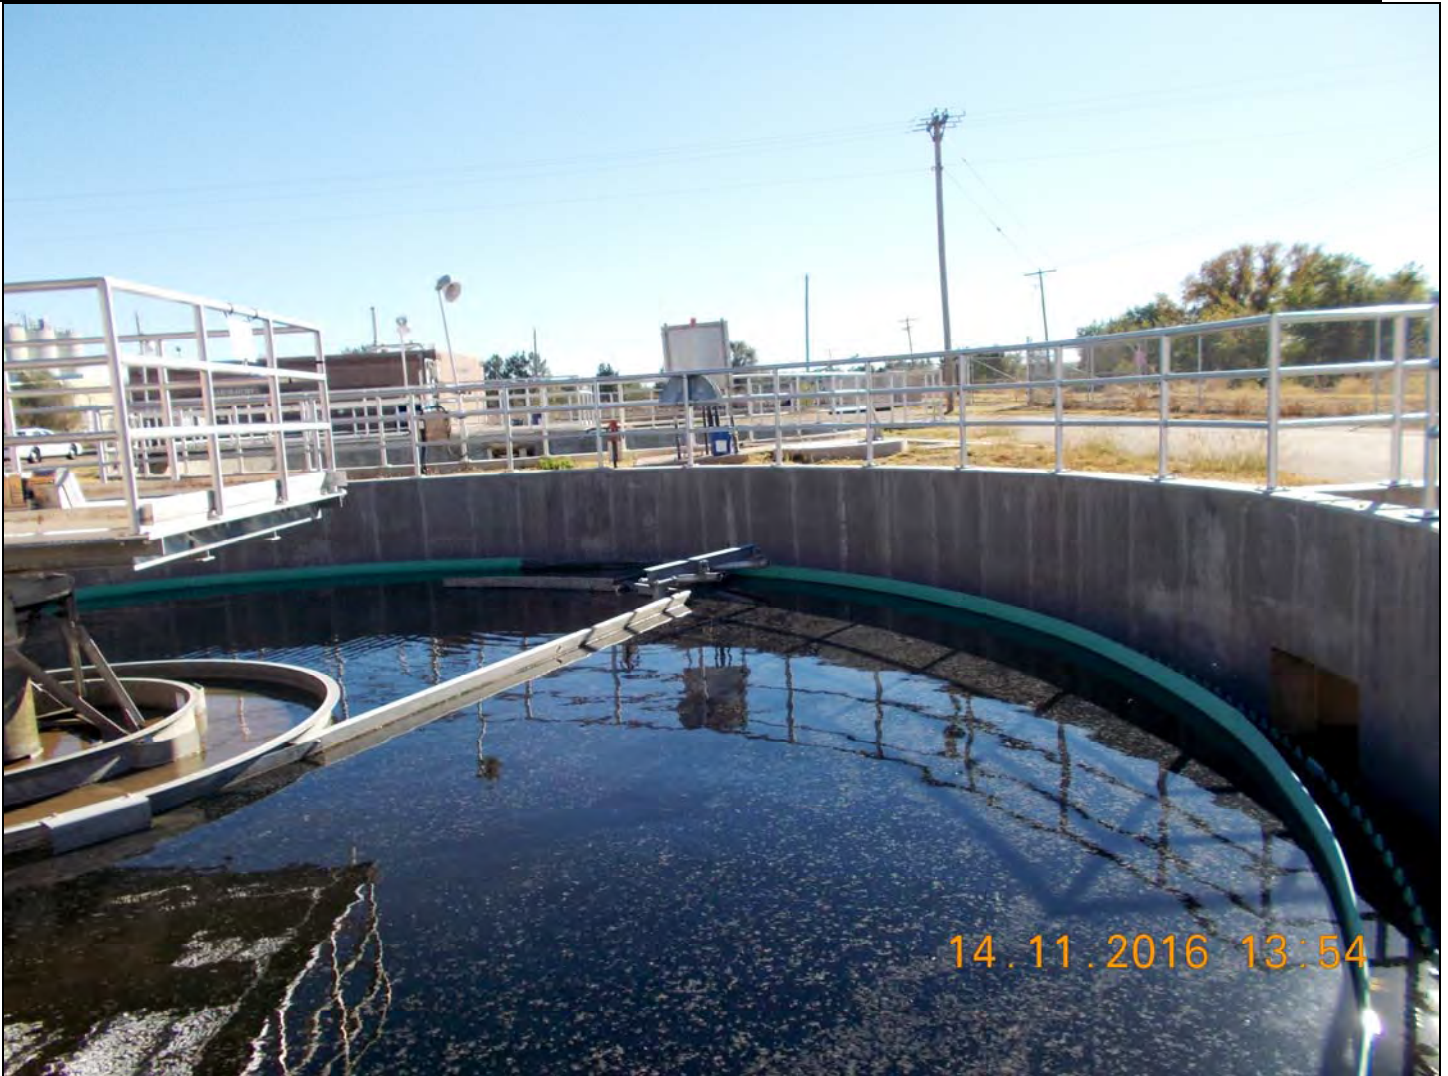
**NMED/SWQB
Official Photograph Log
Photo # 12**

Subject: Decant from the aeration basin is sent to the secondary clarifier. The sludge blanket in the secondary clarifier is 1.5 feet thick. Operators keep a low sludge blanket as a way to accommodate the impacts from the cheese factory. A layer of white flecks of material was evident across the top of the basin. Even with the use of the PAX-14 it was not able to bind with or reduce the presence of the floating cheese waste product. It appeared that most of the floating material was scraped off with the surface skimmer and deposited in the scum trough to be wasted in the sludge digester.

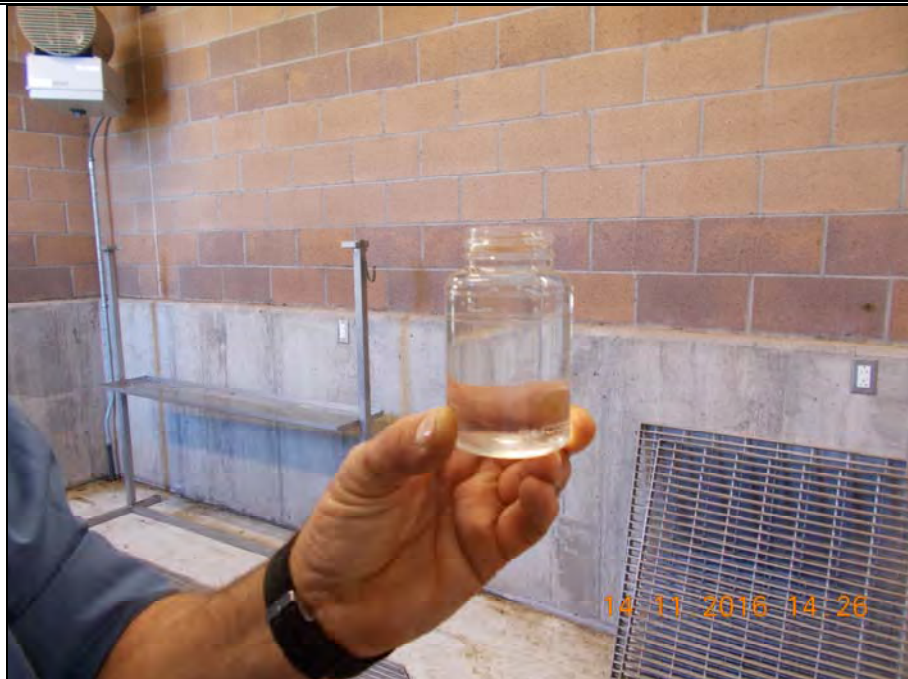
**NMED/SWQB
Official Photograph Log
Photo # 14**

Subject: Following disinfection effluent is collected and sampled for the NPDES permit and the Ground Water permit requirements.

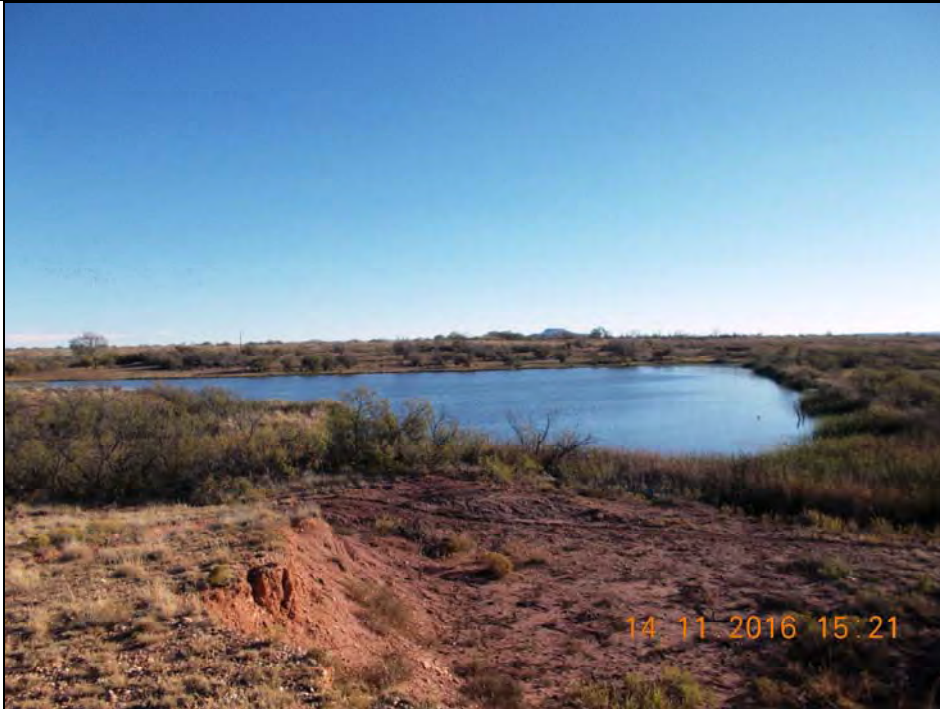
**NMED/SWQB
Official Photograph Log
Photo # 15**

Subject: Subject: Treated effluent is either sent to Breen's pond or to a holding pond for reuse by New Mexico State. Effluent Weir from Breen's Pond to No Name Creek, below Breen's Pond, had no water running through it at the time of this inspection. 100% of the water was being diverted in a PVC pipe for agricultural irrigation.

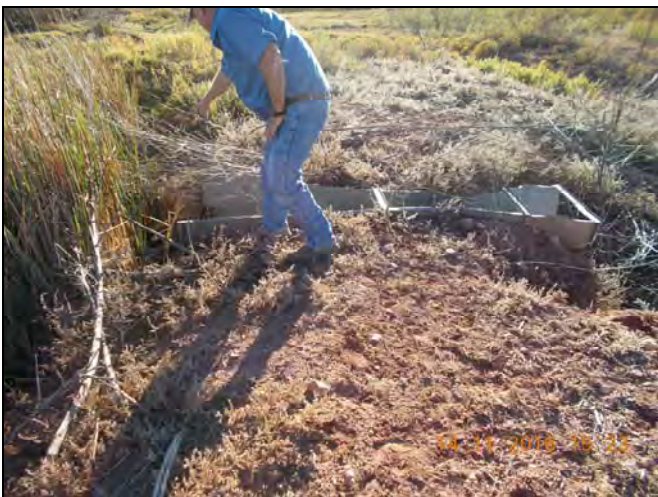
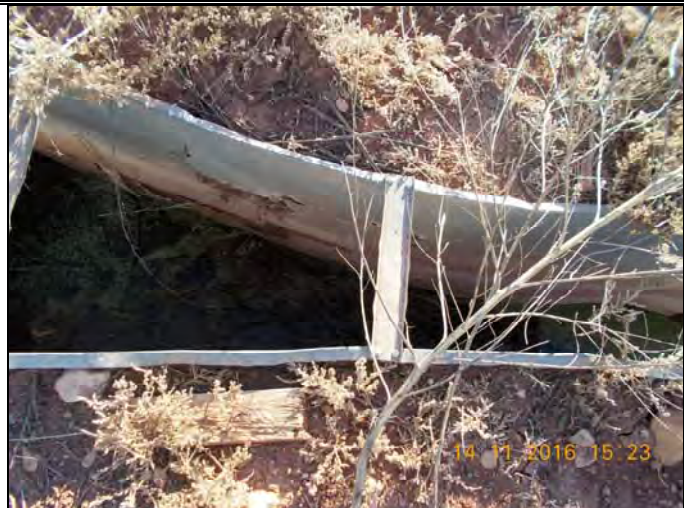
**NMED/SWQB
Official Photograph Log
Photo # 16 & 17**

Subject: Subject: Effluent Weir from Breen's Pond to No Name Creek, had no water running through it at the time of this inspection. The weir was blocked with a board and debris. The flow was being diverted through an approximately 6 inch PVC pipe to agricultural fields.

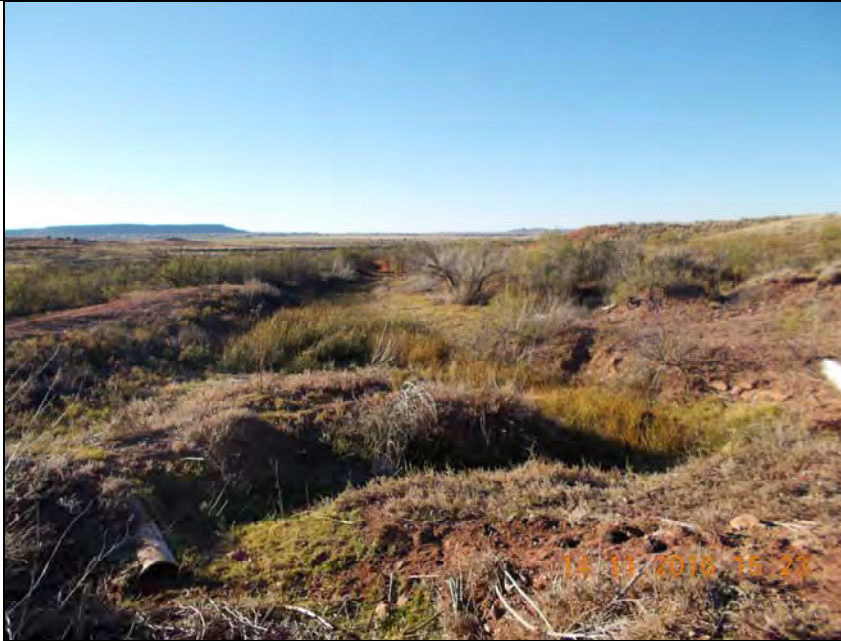
**NMED/SWQB
Official Photograph Log
Photo # 18**

Subject: No Name Creek, below Breen's Pond, had no water running through it at the time of this inspection.

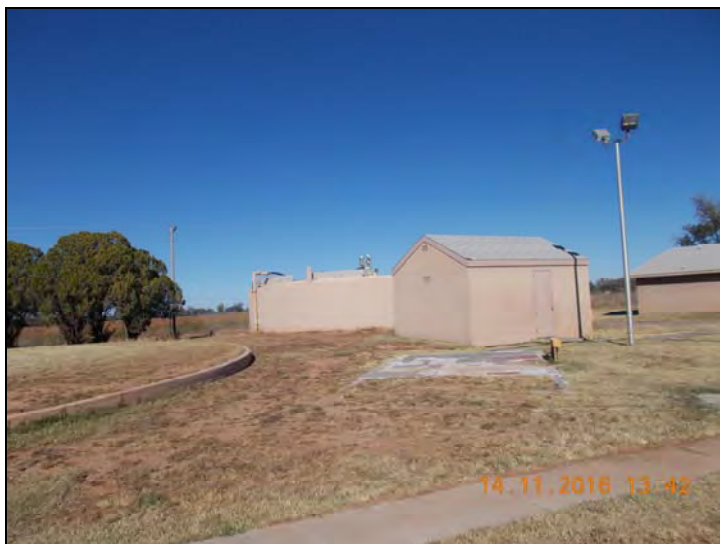
**NMED/SWQB
Official Photograph Log
Photo # 19 & 20**

Subject: Anaerobic digester on the left and aerobic holding tank on the right. Sludge is sent from the second tank to the drying beds. Decant is sent back to the headworks splitter box before the aeration basins.

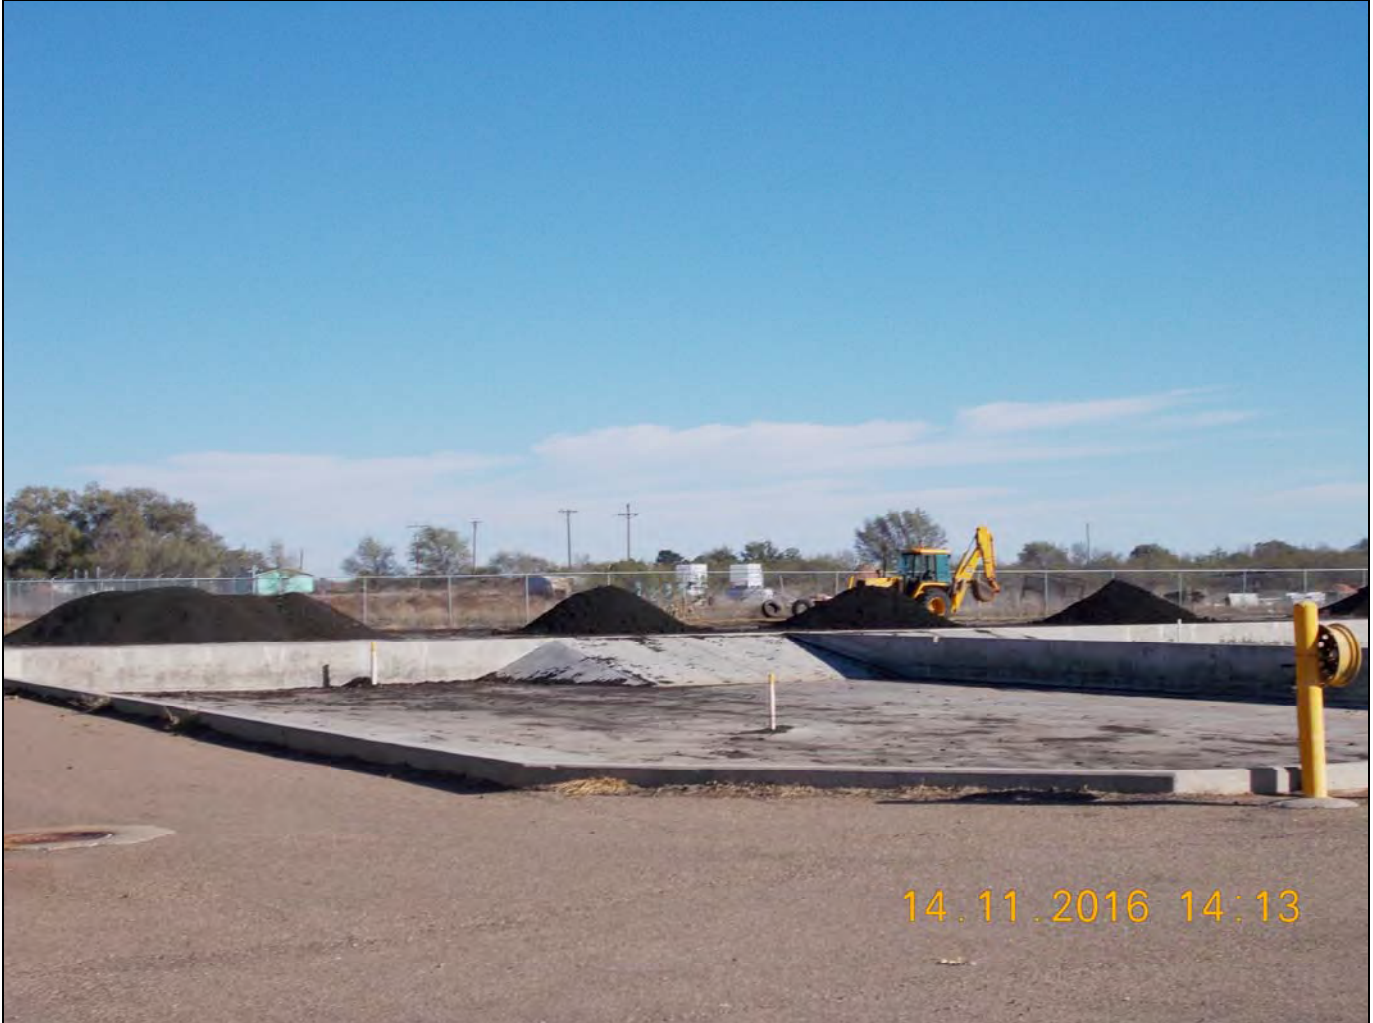
**NMED/SWQB
Official Photograph Log
Photo # 21**

Subject: Sludge drying bed and composting pad with piles of dried sludge in the background.
